Architectural Concrete Repair Images

Explanatory Notes

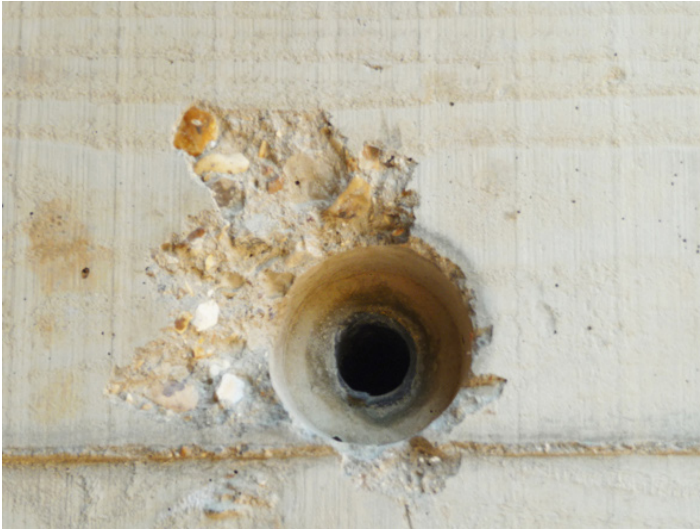
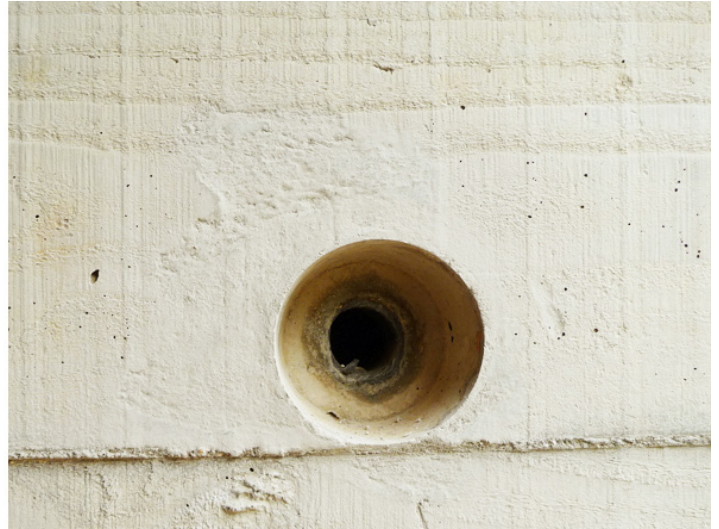
- Tie hole repair (board marked finish GGBS concrete)
- Day joint/expansion joint repair to exterior smooth fair faced finish
- 'Holistic' repair to unsuitable 'bagging up' of extensive blowholes
- Arris edge repair to under compacted board marked finished concrete
- Extensive honeycombing to insufficient compacting of concrete with possible grout loss
- Remedial work to a previously repaired honeycombed concrete.
- Construction damage (board marked GGBS concrete)
